**Mandatory Service Bulletin – Aileron Control Bellcrank Attachment
Inspection**

SB_SONG_02

24.10.2024

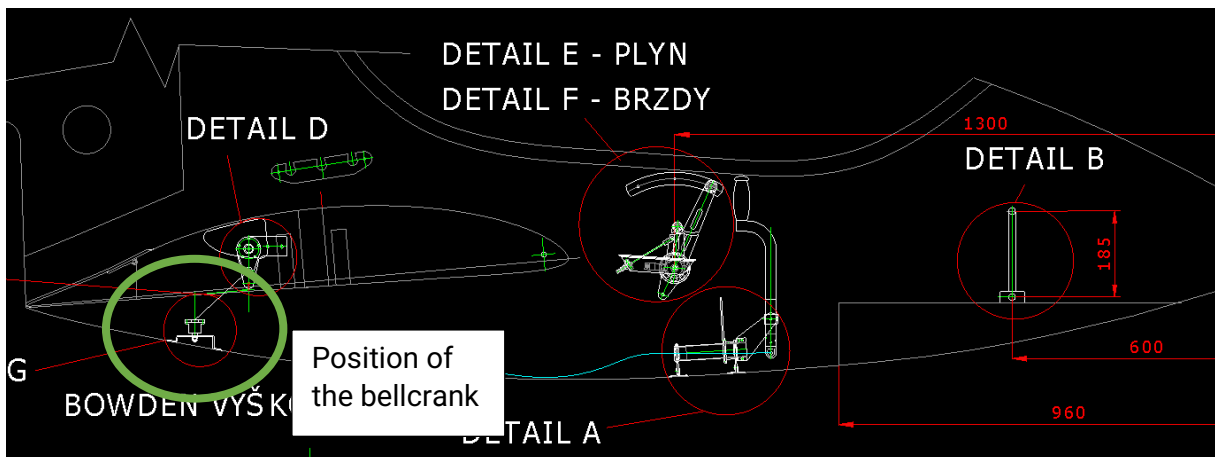
Some s.n. may have the aileron bellcrank in the fuselage installed without the L-console from the top side. This attachment is not rigid enough and may cause the loose of bellcrank and lost of aileron control. See the figure 1 for the position of the affected bellcrank.

Figure 1: Position of affected bellcrank

- 1) Check how is the bellcrank attached in your SONG.
- 2) If your bellcrank is attached as on the figure 2 (below) – no further action is required.

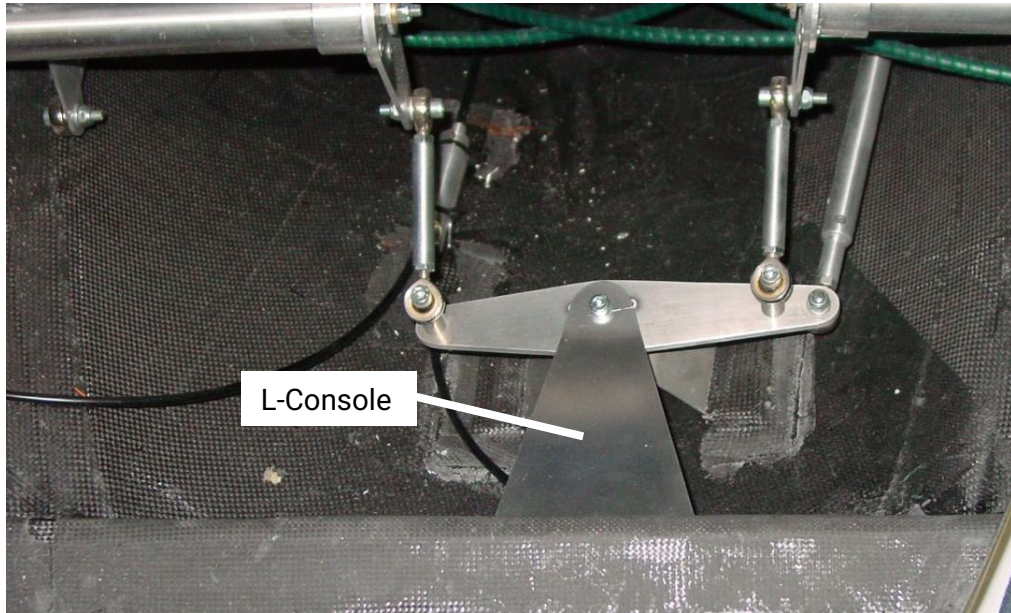
Figure 2: Correct installation of this bellcrank

- 3) If your bellcrank is not installed as shown on the figure 2, continue with following steps:

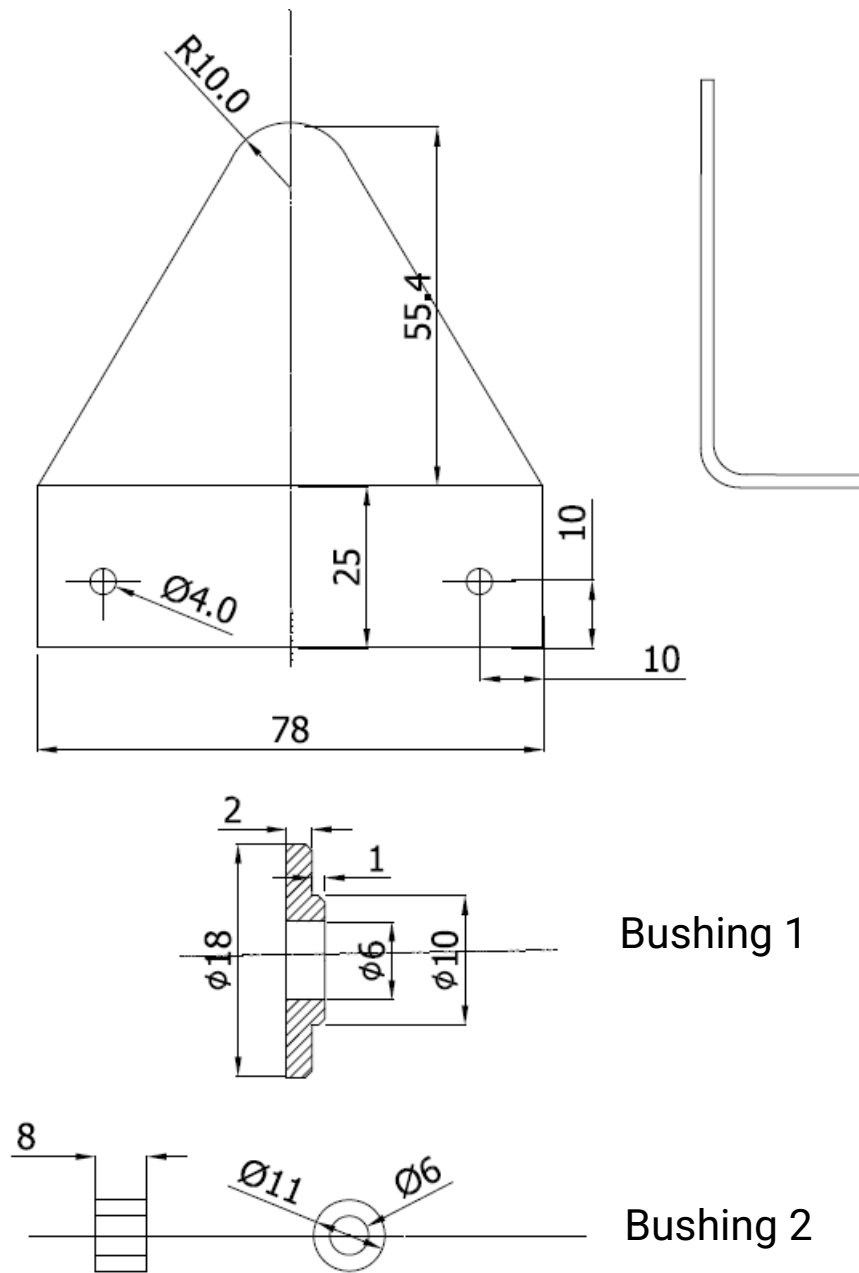
Figure 3: L-console

4) Produce L-console and bushings as shown on figure 3:
