Mandatory Service Bulletin - Wing Pin Washers

SB_SONG_01

Inner wing pins may got unsecured.

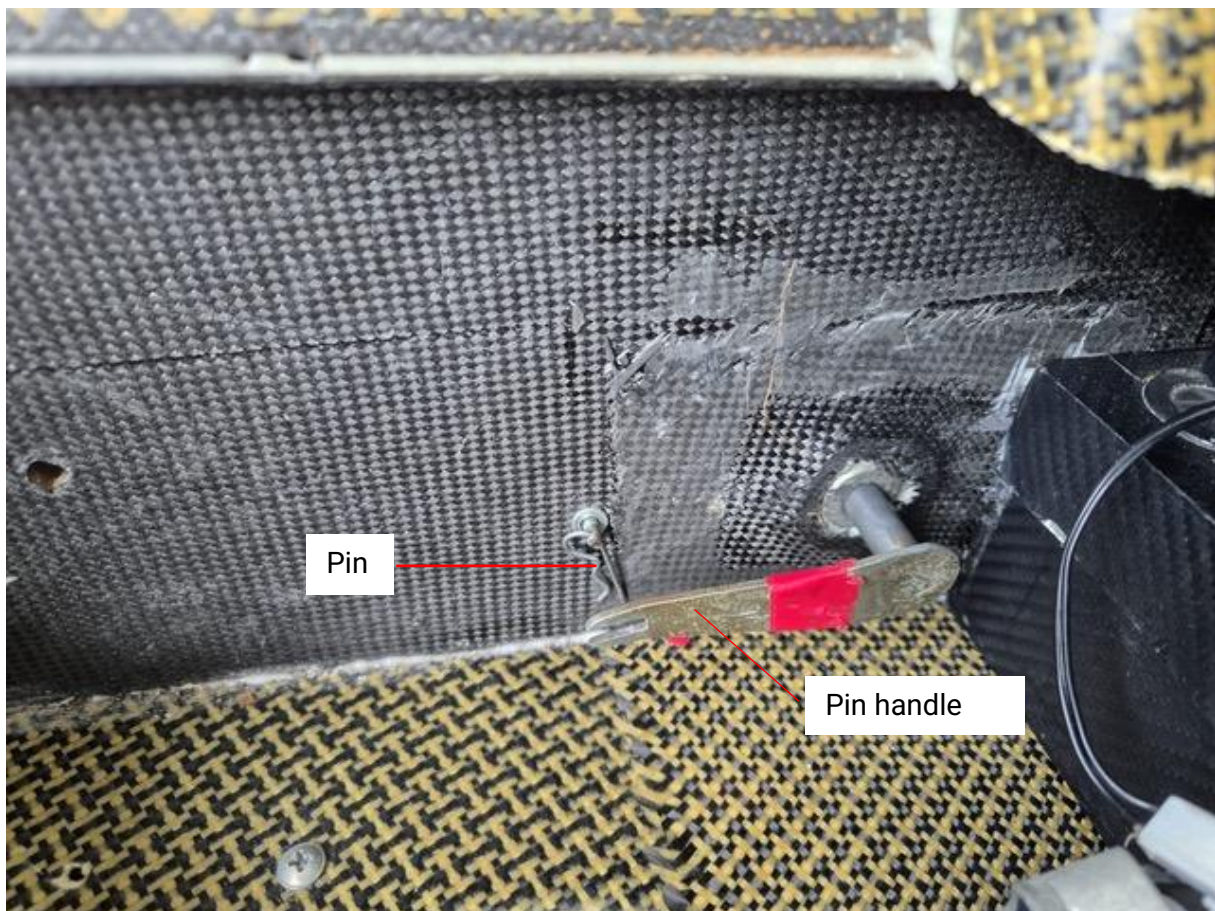
During the preflight check, after the serie of high speed taxing (50km/hod) on the grass RWY a front pin was observed unsecured. Because of vibration, the pin slipped off thru the groove in the pin handle.

- 1) Check what type of pin handle is used in your SONG.
- 2) If you have a handle without the groove (just with a round hole) then, no further action is required.
- 3) If you have a handle with the groove, insert a washer between the handle and the pin to secure it.
